Flight Test – FINAL REPORT – Revision 3 - (4/10/17)
The EAGLE AOA display with Flap Biasing
in the
Beechcraft King Air 90 Blackhawk
AlphaSystems Angle of Attack Stall Warning System

This flight test (Rev3) was flown to evaluate the information provided by the Alpha Systems Angle of Attack (AOA) Stall Warning System as displayed on the **Eagle AOA display with newly-introduced flap position sensors** in six normal flight configuration and attitude combinations of the Beechcraft King Air 90 Blackhawk aircraft to determine the usefulness of that information at enhancing safety in the operation of general aviation aircraft. **This flight test (Rev3) focuses entirely on the features of flap-biased AOA software, an advance from earlier non-biased software. This report is otherwise very similar to Revision 2 - (7/10/14).**

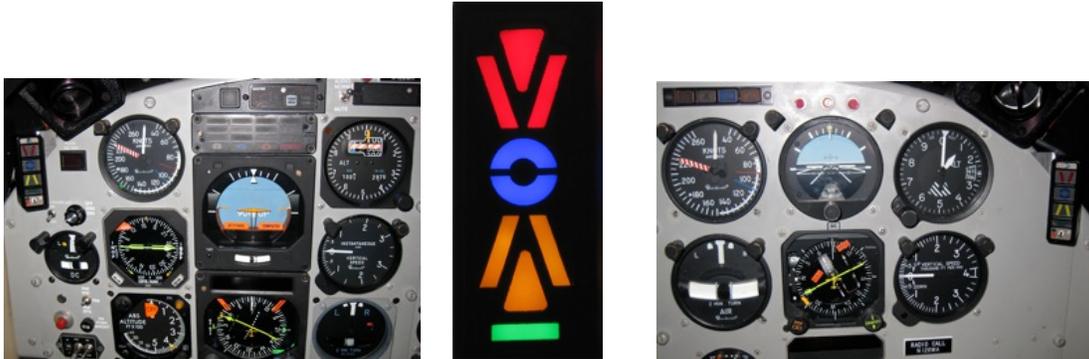
The Alpha Systems AOA Eagle Display provided visual and audible indications as shown in Figure 1 and Table II below. The two triangles are newly added:

**Alpha Systems AOA Stall Warning Eagle Electronic Display
Dual Eagle AOA Indicators in a King Air 90**

Condition	Display Indication
Cruise	Green Bar
Slowing From Cruise	Green Bar and Amber Triangle
Slowing Further From Cruise	Amber Triangle
Slow Flight	Amber Triangle and Amber Chevron
Very Fast (reference the donut)	Amber Chevron
Fast (reference the donut)	Amber Chevron and Lower Half of Blue Donut (Various callouts are available at this indication)
Slightly Fast (reference the donut)	Lower Half of Blue Donut
On Speed (OAA)	Full Round Blue Donut
Slightly Slow (reference the donut)	Upper Half of Blue Donut
Slow (reference the donut)	Upper Half of Blue Donut and Red Chevron
Very Slow (reference the donut)	Red Chevron
Ultra Slow (reference the donut)	Red Triangle

Alpha Systems AOA Stall Warning Eagle Electronic Display System Indications

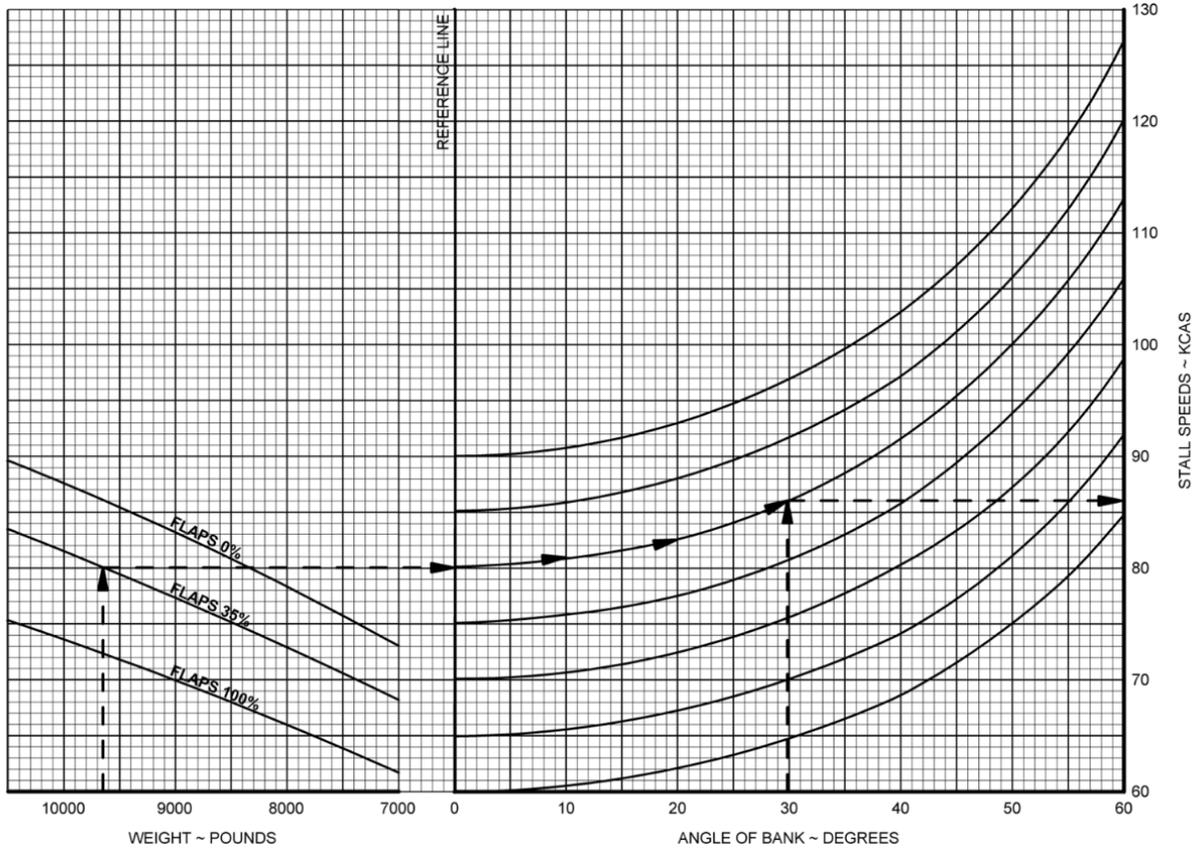
Table IX (for the Raisbeck EPIC C90 Blackhawk)

STALL SPEEDS - ZERO THRUST

1. MAXIMUM ALTITUDE LOSS DURING STALL RECOVERY IS APPROXIMATELY 850 FEET.
2. POWER FOR ZERO THRUST (APPROXIMATELY 150 FT-LBS TORQUE AND 1750 PROPELLER RPM).
3. POWER-OFF STALL SPEEDS ARE APPROXIMATELY 4 KNOTS HIGHER THAN THOSE WITH ZERO THRUST.

WEIGHT 9,650 LBS
 POWER ZERO THRUST
 GEAR DOWN
 FLAPS 35%
 ANGLE OF BANK 30 DEGREES
 STALL SPEED 86 KCAS

1: The flight test King Air C90 Blackhawk is substantially identical to the Raisbeck EPIC C90 with the Blackhawk engines. From this Stall Speed vs. Weight graph, we can compare our Table VIII flight test data to Raisbeck’s Table IX flight-tested data to see whether the flap bias input is accurate. Using the Table IX graph (while recognizing that our flights’ power was set a bit higher at ~300 Ft-Lbs), we determined:

In the Landing configuration at 9,720 lbs., we find a wings-level $V_{SO \text{ Landing}}$ stall speed of 73 KIAS which would suggest an Optimum (Donut) AOA speed at $1.3 V_{SO \text{ Landing}}$ of 95 KIAS. That compares quite nicely with our flight test data for that configuration both with and without flap biasing ... which is what one would expect.

In the Clean configuration at 9,800 lbs., we find the $V_{S \text{ Clean}}$ stall speed of 87 KIAS which would suggest an Optimum (Donut) AOA speed at $1.3 V_{S \text{ Clean}}$ of 113 KIAS. That airspeed again compares favorably with our flight test data results for the flap-biased Clean configuration. It’s only 1.7 KIAS higher than our averaged “high end of range” data for our three test runs.

- The Optimum (Donut) AOA is a relatively linear progression from $1.3 V_{SO \text{ Landing}}$ to $1.3 V_{S \text{ Clean}}$
- The Flap Bias calibration procedure allows for accurate replication of the Beechcraft King Air 90 Blackhawk's 18 KIAS difference between $1.3 V_{SO \text{ Landing}}$ and $1.3 V_{S \text{ Clean}}$ airspeeds or the 14 KIAS difference between the graph-provided $V_{SO \text{ Landing}}$ and $V_{S \text{ Clean}}$ stall speeds

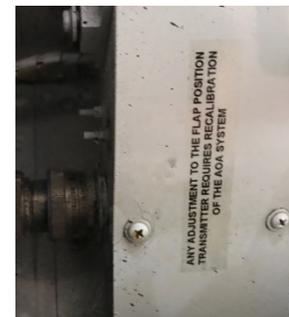
4: The Flap Position Transmitter should have a placard to warn the maintaining crews and a parallel Instruction for Continuing Airworthiness*. It will be far too easy for a technician to adjust the transmitter or flap rigging while being unaware that the aircraft has a AOA that's dependent on its rigged position. **[Our thanks to Paul Sneden]*

So, we installed a placard to serve as an example → → → → → →
